APOLLO 9 MISSION REPORT

MAY 1969

Mission Evaluation Team

George M. Low
Manager, Apollo Spacecraft Program

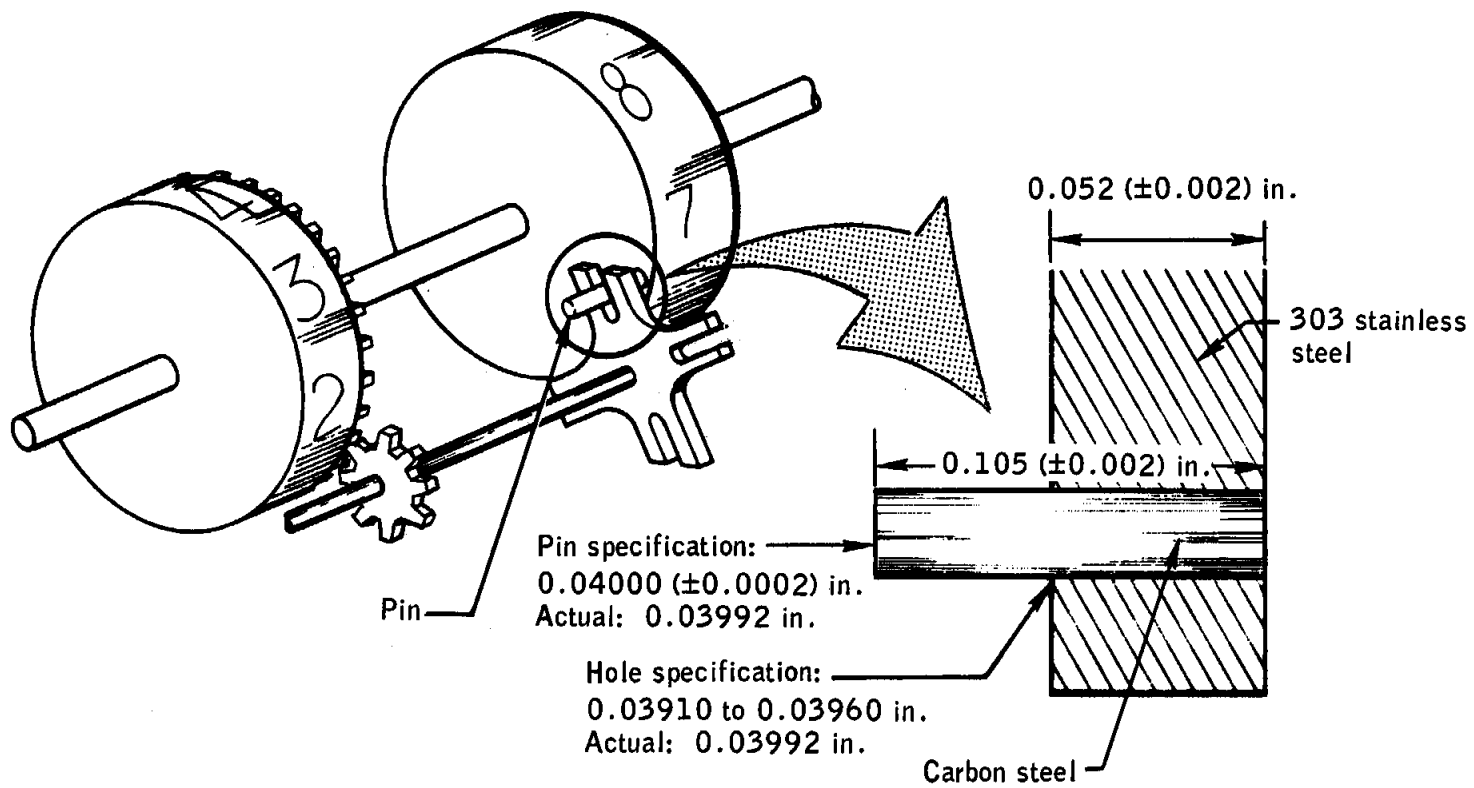
Figure 17-4.- Scanning telescope counter.

The counter malfunction was caused by the pin on the "tenths" drum dropping out (fig. 17-4) and eventually jamming the gear. One revolution of the counter shaft results in the pin engaging a geneva gear which is meshed to the "units" drum of the counter. If the pin is missing, the "tenths" drum will rotate but, the "units" drum will not be engaged through the geneva mechanism, resulting in no movement of the degree indicators of the counter. The intermittent sticking of the shaft was caused by the loose pin from the counter lodging between the split anti-backlash gear on the shaft resolver. Repeated operation of the manual adjust screw with the universal tool eventually wedged the pin between the anti-backlash gears, providing proper mesh of the gear train; this, in turn, freed the telescope shaft and enabled proper freedom of motion. Detailed tolerance measurements of the failed unit show that all parts conformed to the drawings and specifications with the exception of the hole on the "tenths" drive hub. The hole, which should have retained the pin, was out of tolerance. Figure 17-4 shows the pin/hole interface specification dimensions for this assembly. The hole dimension of the failed part was +0.00032-inch oversize in diameter, resulting in a hole diameter of 0.03992 inch. The pin diameter was measured to be 0.03992 inch. The specification requires an interference fit of 0.0002 to 0.00011 inch. Dynamic load analysis of the counter and a tolerance study of the pin/hole interface indicates that the design is adequate. The failure was the result of an out-of-tolerance hole on the drive hub of the "tenths" drum. Repeated impact by the geneva mechanism resulted in the pin slipping from the hole sufficiently to come into contact with the pinion gear on the counter shaft. Impact by the pin on the pinion gear resulted in the pin dislodging from the drive hub.

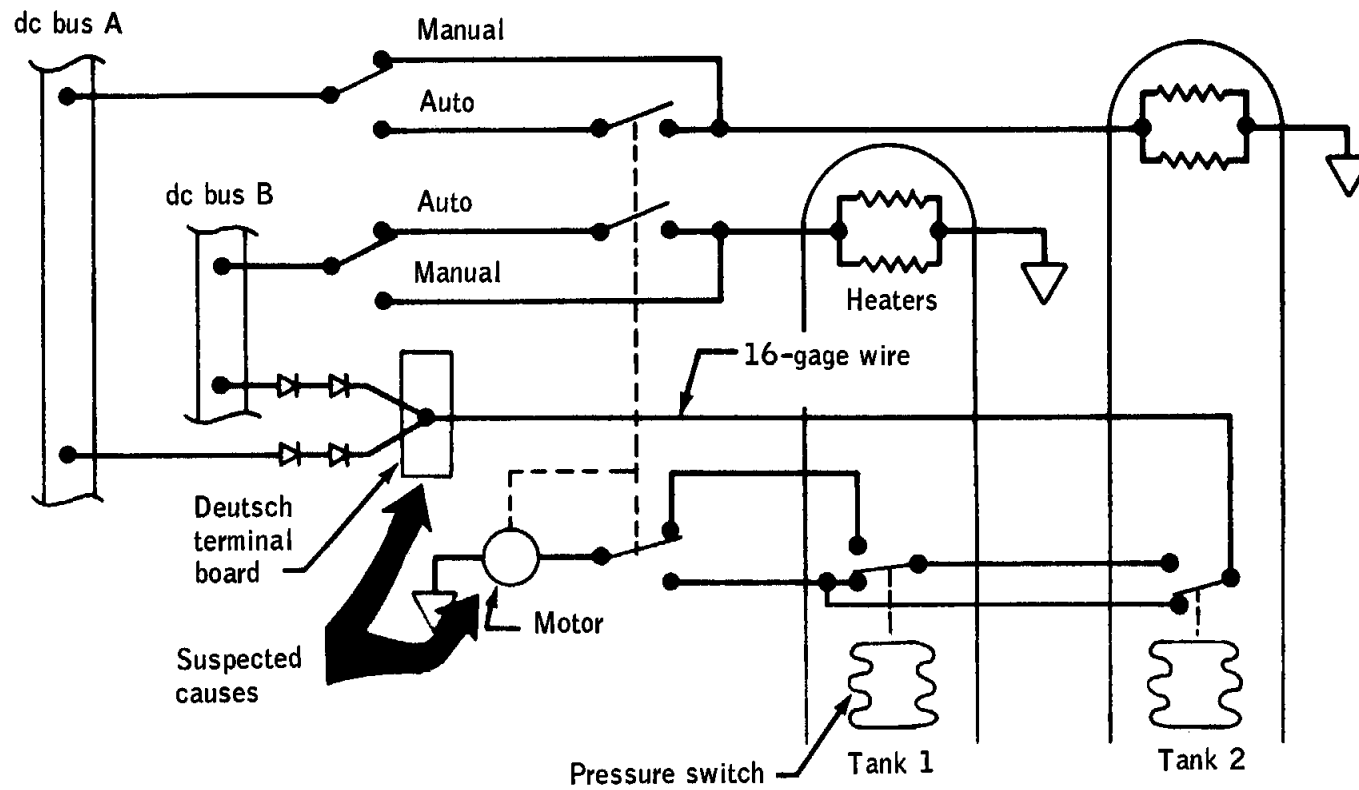
Figure 17-5.- Hydrogen tank pressure control.

During the flight, the automatic pressure control system in the hydrogen tanks failed. The logic of the control system (fig. 17-5) is such that the pressure switches in both tanks must close in order for the heaters to be activated; however, opening of only one pressure switch will deactivate the heaters. The first indication of failure was noted at 93 hours, shortly after the initial undocking, when the heaters were not automatically activated (fig. 17-6). At approximately the time of the final lunar module undocking, all hydrogen tank heaters came on and pressurized the tanks to about 270 psia, which required that the heaters be turned off manually.

Since the first failure (failure to turn on) would have required one pressure switch to fail open and the second failure (failure to turn off) would have required that both pressure switches fail closed, the switches can be ruled out. The most probable cause for the failures was an intermittent open-circuit condition in the motor control circuit (including the power line, ground, and the terminal board for 16-gage pins) resulting from the undocking shock (see fig. 17-5). Sixteen-gage terminal boards have been the source of intermittent contact in other circuits during ground tests.

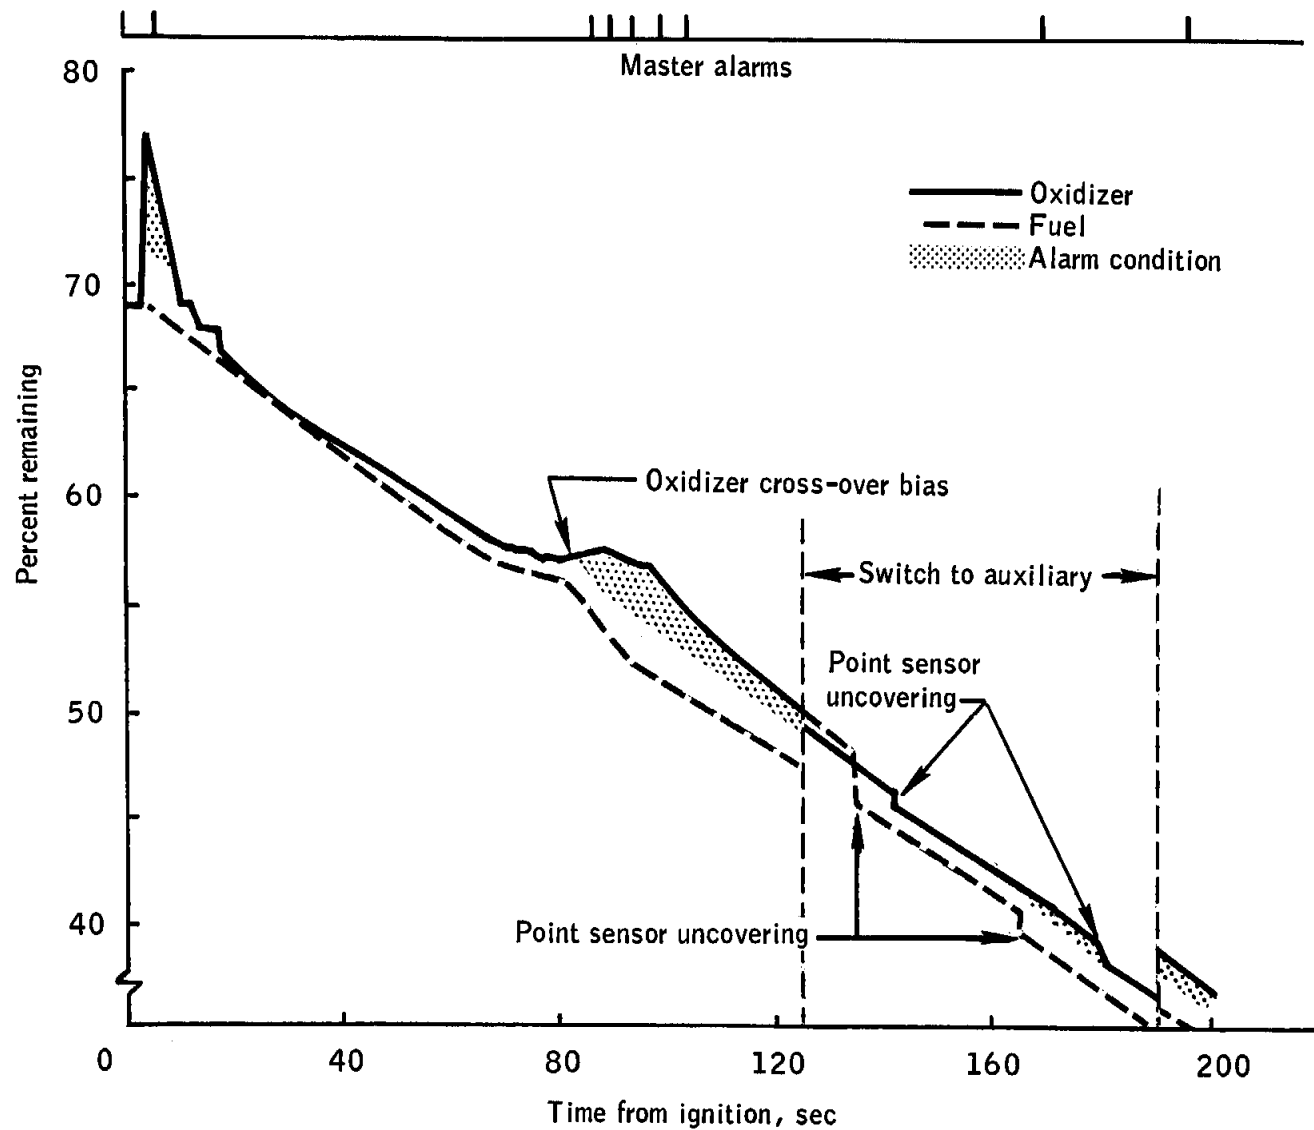
Figure 17-7.- Service propulsion system propellant quantities.

During the third firing of the service propulsion engine, there were eight master alarms from the propellant utilization and gaging system indicating an excessive propellant unbalance (fig. 17-7).

All the master alarms are explainable. The first alarm was caused by propellant level in the capacitive measuring tube not reaching the settled level as soon as expected after start-up. The next five alarms, shown in figure 17-7, resulted from an electrical zero bias in the oxidizer measuring circuit after storage tank depletion. Thus, continuous alarms on the primary gaging system caused the crew to switch to the auxiliary system, which employs point sensors at discrete levels in the tanks.

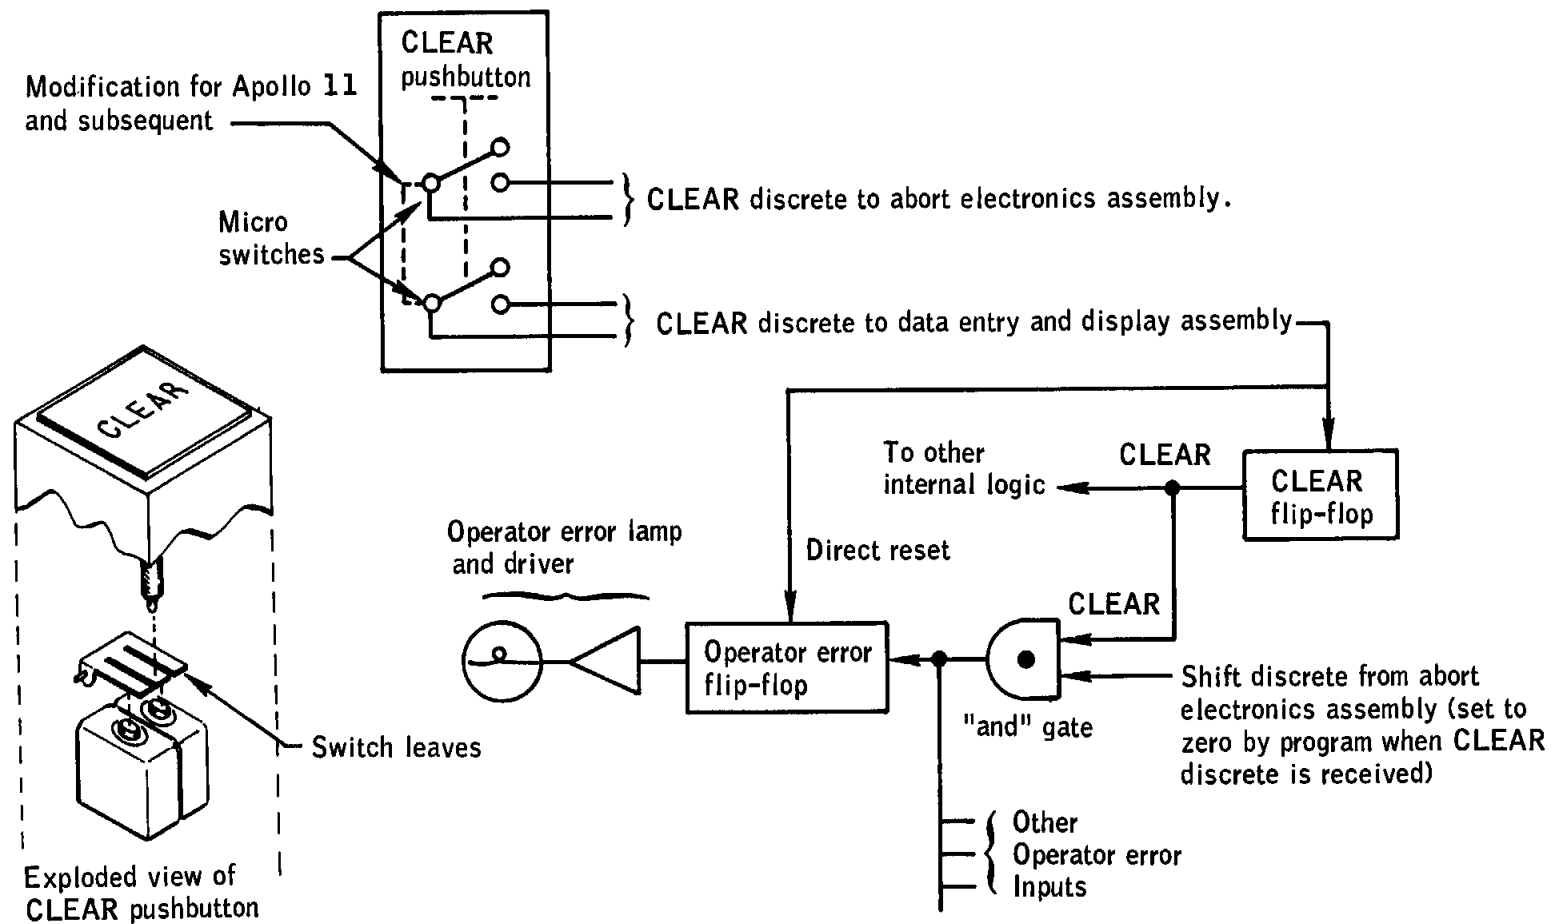
A simplified diagram of the CLEAR pushbutton logic circuit is shown in figure 17-27. The pushbutton contains two microswitches which are designed to activate within 30 milliseconds of each other after the button is depressed. The CLEAR pushbutton microswitches issue discretes to the data entry and display assembly and to the abort electronics assembly. The data entry and display assembly discrete extinguishes the operator error light directly as shown and also sets the clear flip-flop. The clear flip-flop issues a logic "one" to an "and" gate as shown and to other internal logic. The abort electronics assembly discrete is used in program control for several operations which include setting the shift discrete shown in the figure to "zero."

Figure 17-27.- Simplified data entry and display assembly operator error light circuit.

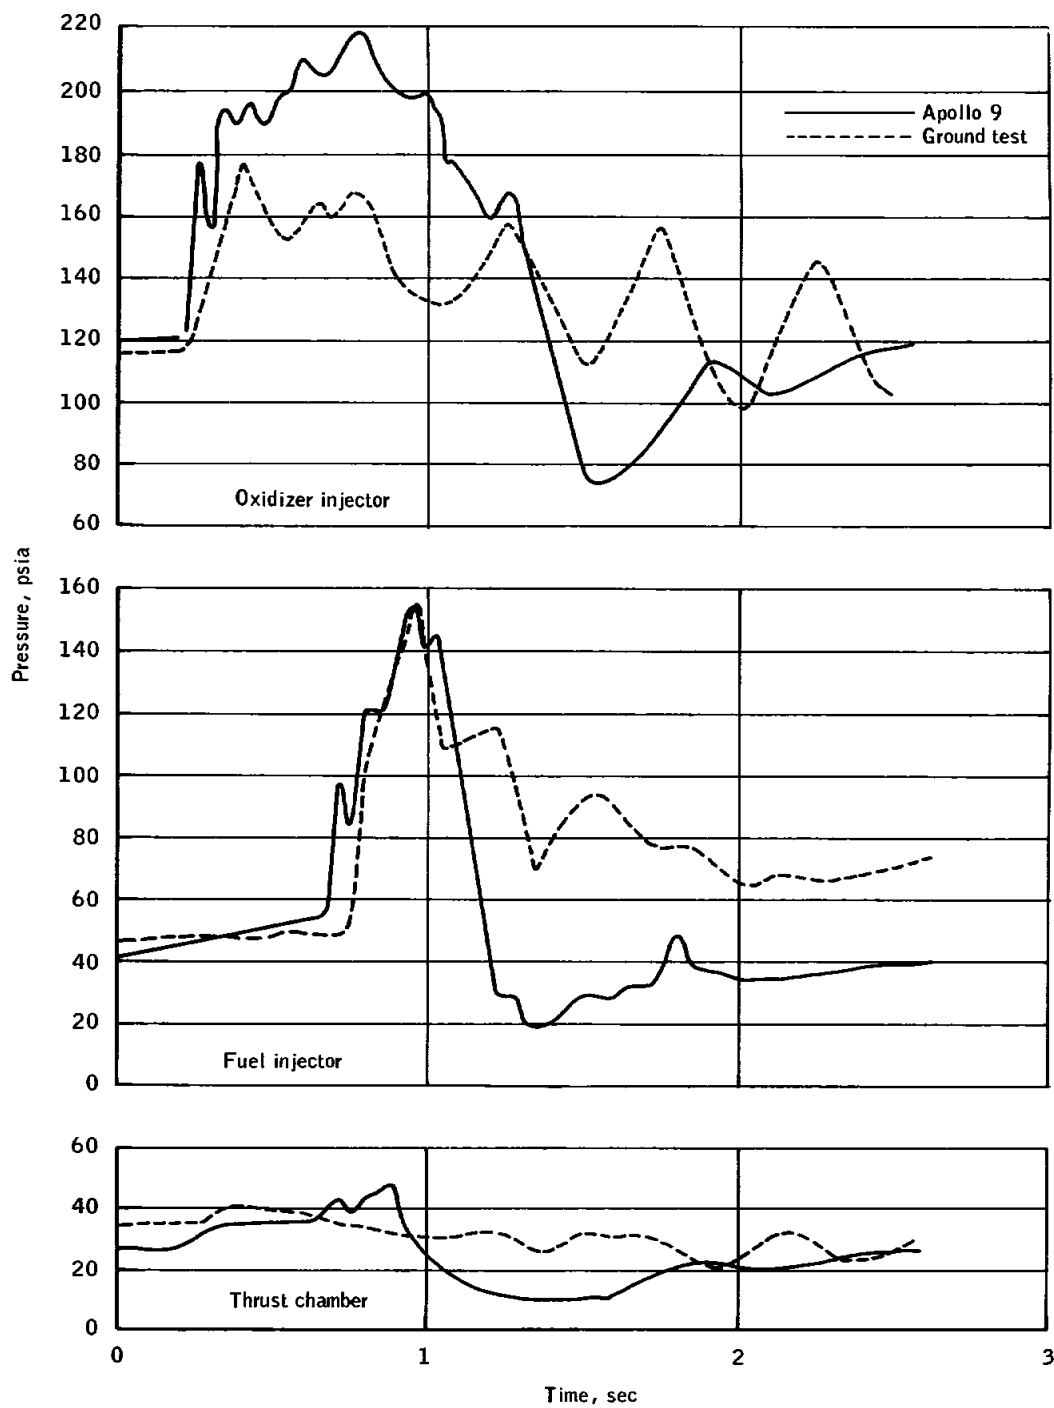
Tests have shown that with helium deliberately introduced into the propellant lines, the interface pressures increase as the gas passes the throttle assembly, because the throttled area operates at cavitating pressures. The variation of interface pressures and the bleeding of helium into the injector results in fluctuations in the engine chamber pressure. These test results match very closely the flight data during the engine roughness (fig. 17-28).

Figure 17-28.- Comparison of roughness during second descent engine firing and ground tests.

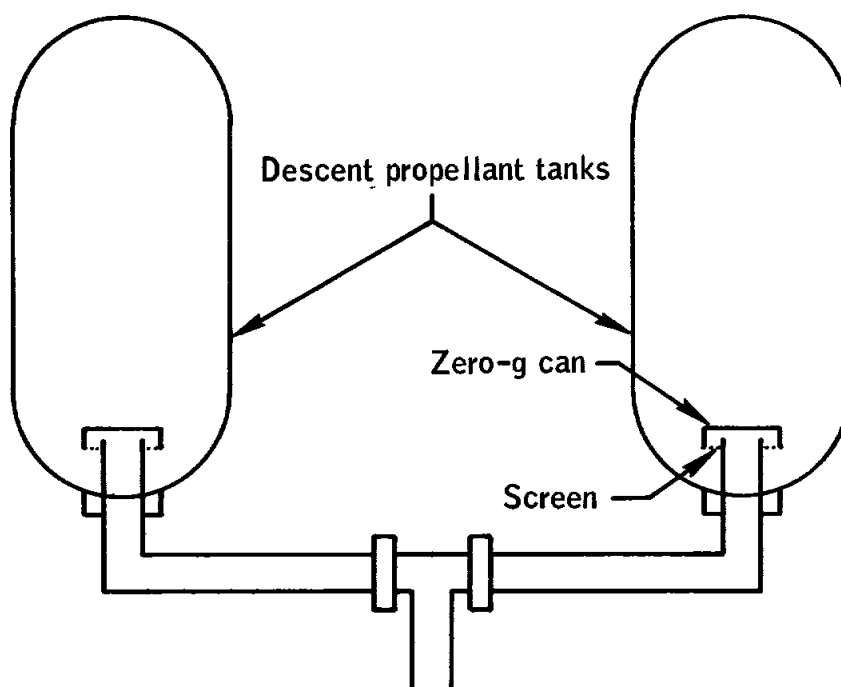
propellant head within the zero-g can itself. During lateral and rotational accelerations, the actual propellant head includes the 114 inches of connecting line between the two parallel tanks (see fig. 17-29). Helium ingestion requires that the zero-g can be uncovered and that lateral or rotational accelerations be present. This was highly probable with the 60-percent ullage volume present in Apollo 9 propellant tanks prior to the second descent engine firing. However, if helium should be introduced into the line, the engine would fire roughly sometime during the first several seconds of the firing. In any event, tests have demonstrated that ingestion of helium into the engine in this manner has no detrimental effect on the system.

Figure 17-29.- Descent propellant tank manifolding.

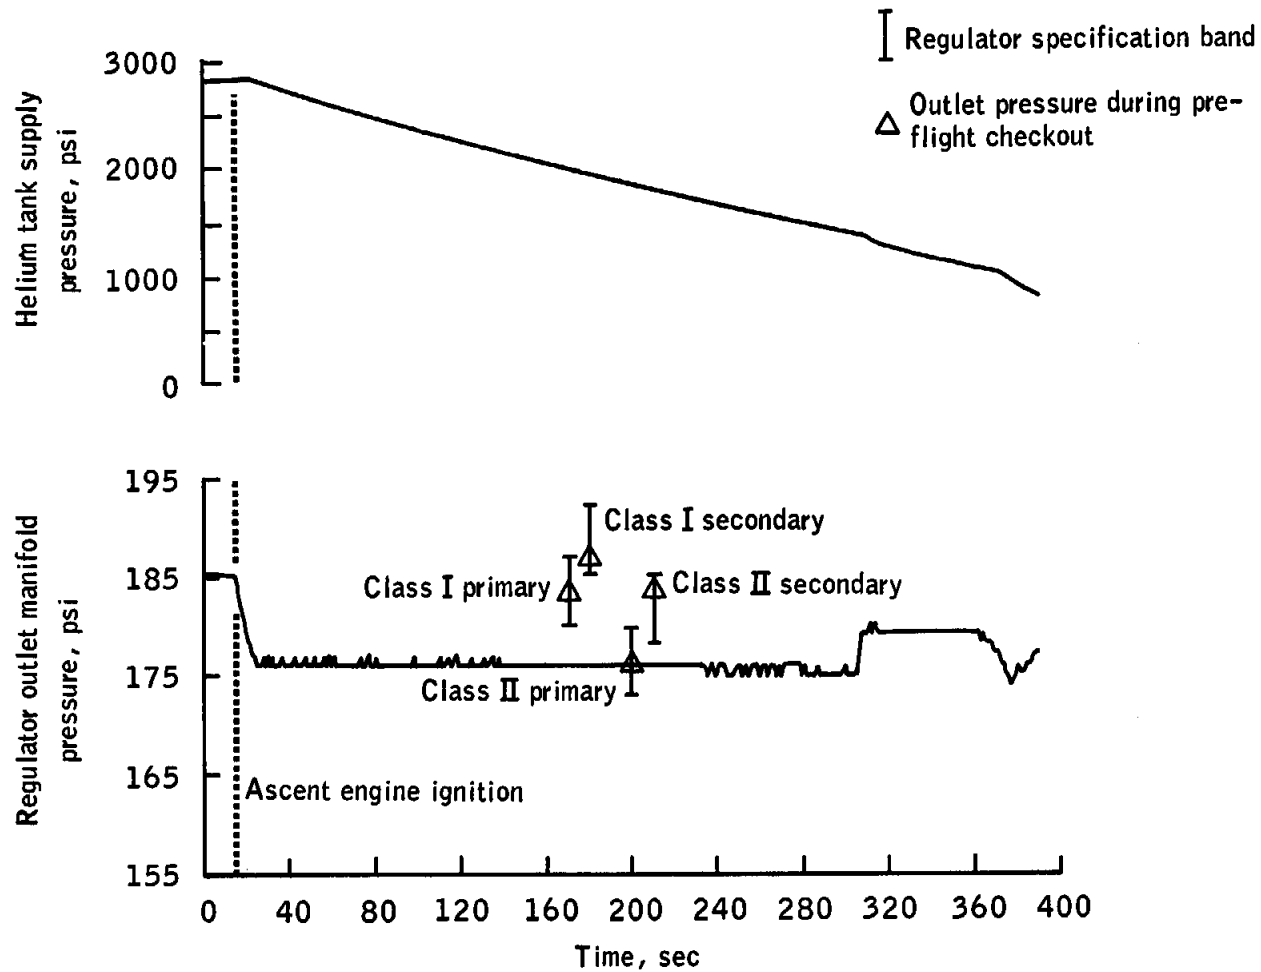
Figure 17-30 shows the helium supply pressure and regulator outlet pressure during this firing. Also presented are the regulation bands of each of the helium regulators as well as the pressure at which they were regulating during checkout at the launch site. The class I primary is normally the controlling regulator. As shown in figure 17-30, the regulator outlet pressure was 8 to 10 psi lower than nominal class I primary regulated pressure during most of the firing.

Figure 17-30.- Helium tank and regulator outlet pressures during ascent engine firing to depletion.

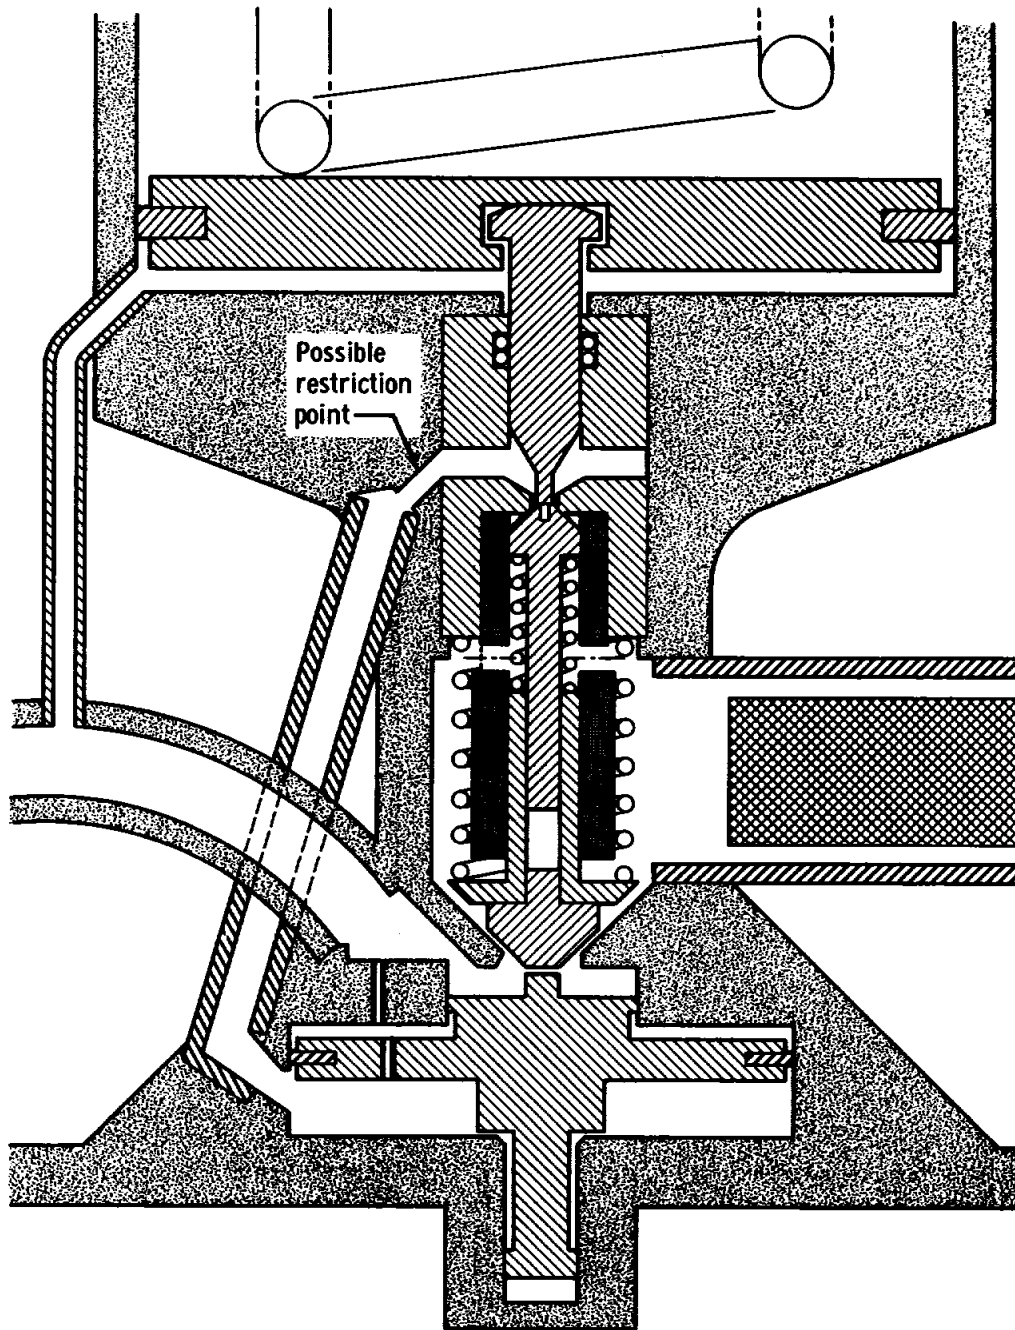
At this time, the most likely conditions which could have caused the indicated malfunction of the class I regulator (see fig. 17-31) was contamination of the regulator. This contamination could have caused a restriction in the feedback line from the pilot poppet to the slave piston. Tests have shown that a regulator band shift can result by reducing the

Figure 17-31. - Cross section of ascent propulsion system regulator.

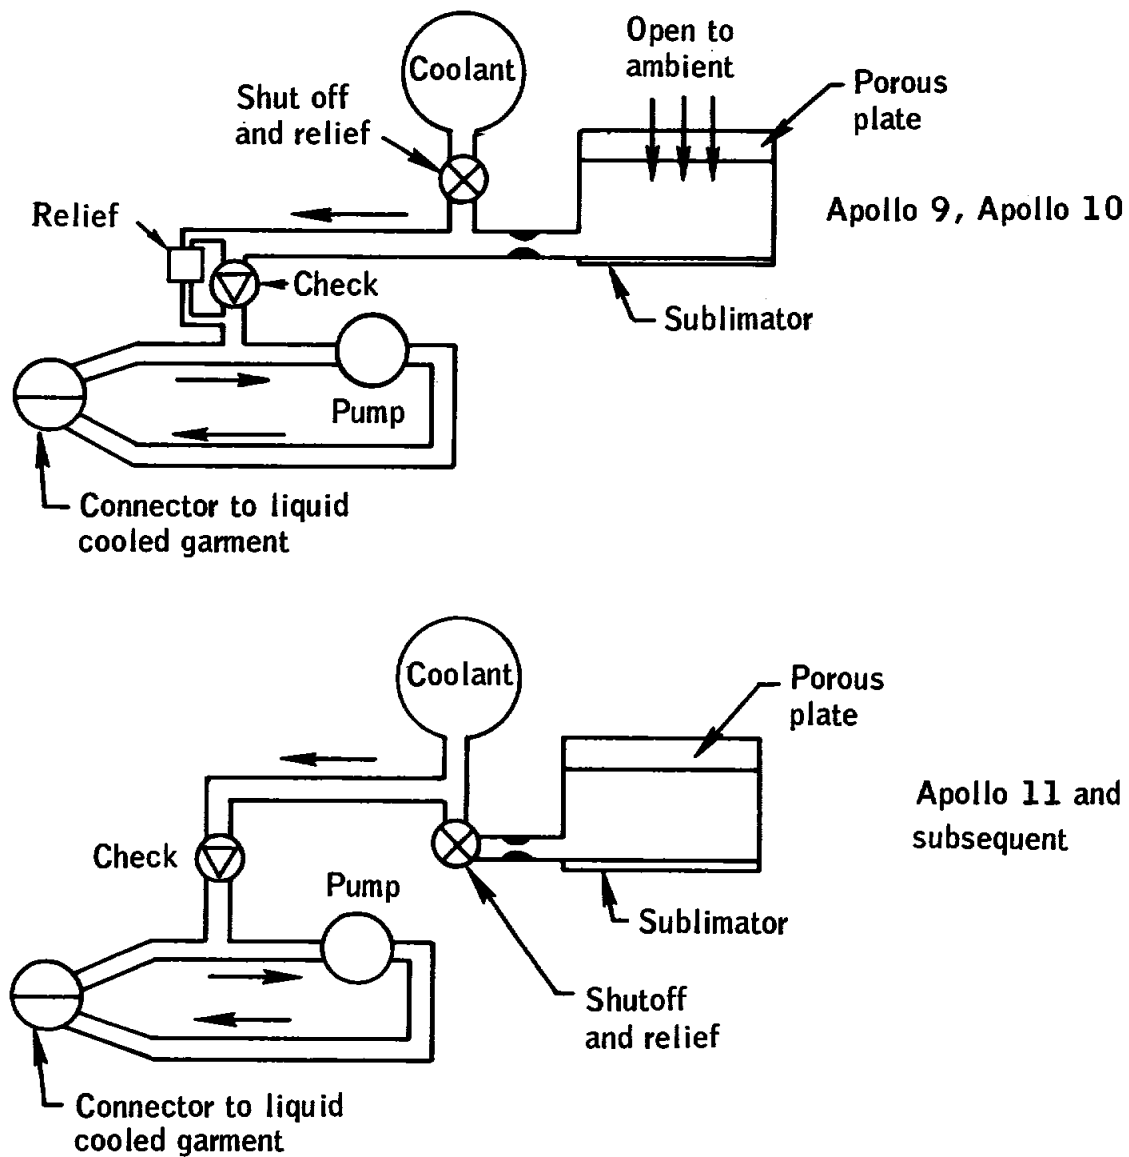
When the Lunar Module Pilot removed his liquid cooled garment after completing the extravehicular activity, he noted many air bubbles entrained in the liquid tubes.

The preflight procedure for charging the portable life support system has been eliminated as a possible source of air inclusion into the system. The air most probably entered the system when the portable life support system was being connected to the liquid cooled garment in the pressurized lunar module cabin. Because of the location of the coolant make-up line for the portable life support system, air is ingested through the sublimator into the coolant loop (fig. 17-32) whenever the total pressure in the liquid cooled garment is less than that in the portable life support system. The amount of air bubbles observed also corresponded roughly to the amount experienced in ground tests whenever the liquid cooled garment had been connected to the portable life support system after having been out of its storage bag, and detached from the life support system for 24 hours. The portable life support system has been redesigned to eliminate this problem for the Apollo 11 hardware (fig. 17-32). This change will relocate the make-up line to the upstream side of the water shutoff and relief valve, and any pressure make-up will be replenished with water instead of gas.

Figure 17-32.- Air in liquid cooled garment at time of connection to portable life support system.

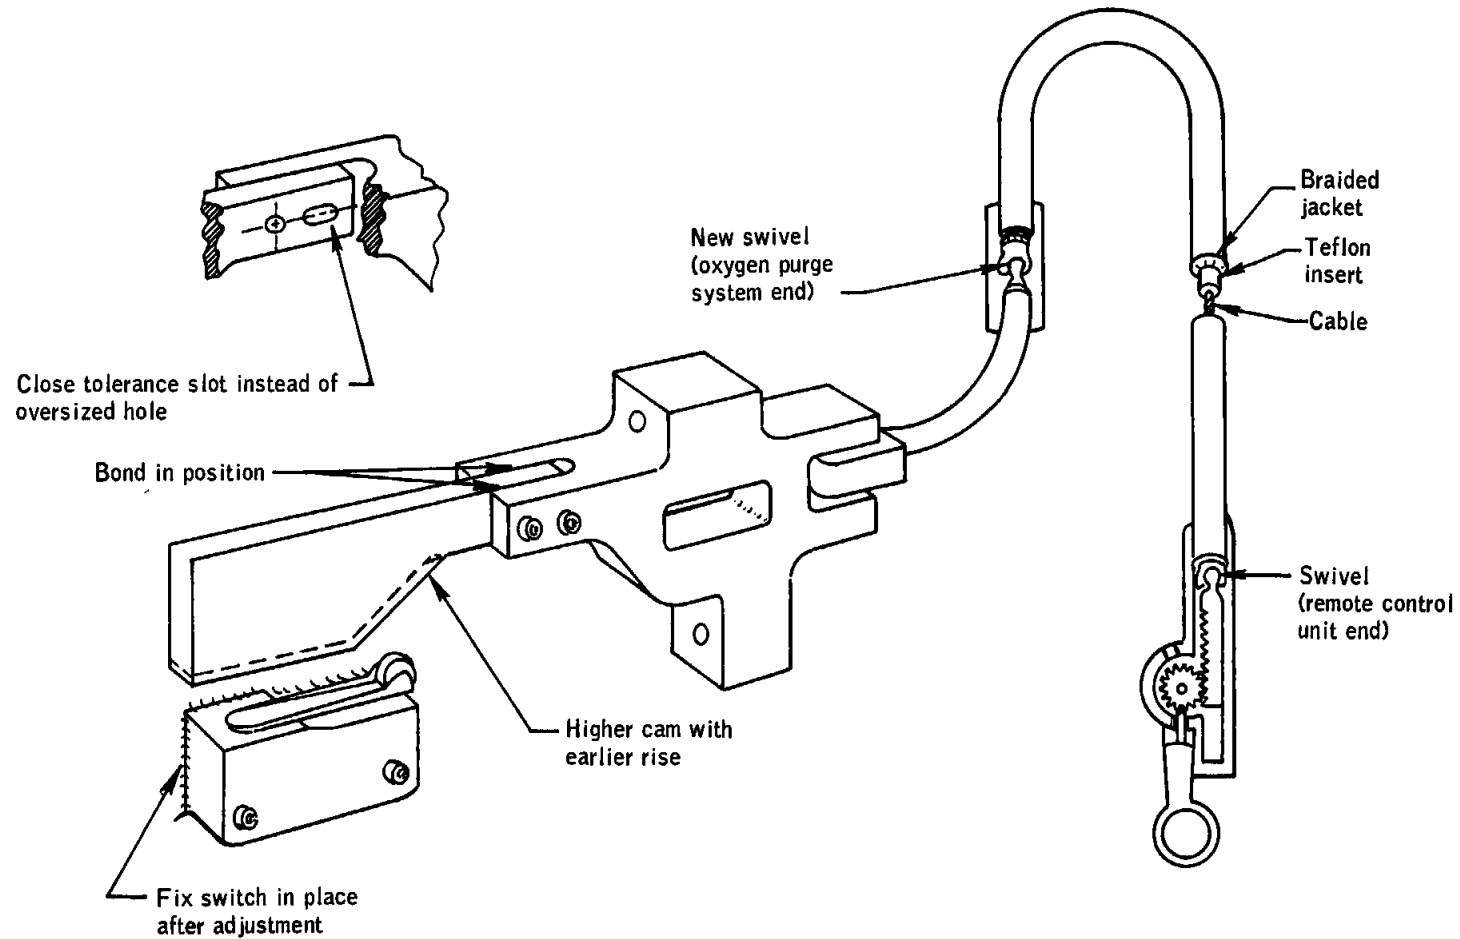
The checkout light on the Commander's oxygen purge system operated erratically during the flight and failed to come on during preparations for rendezvous. An examination of all possible conditions that could have caused the failure indicates that the main power switch actuator

Figure 17-33.- Oxygen purge system heater power switch actuator mechanism changes for Apollo 10.

mechanism did not close the switch. The following changes were incorporated into the actuator mechanism (fig. 17-33) for Apollo 10 and subsequent:

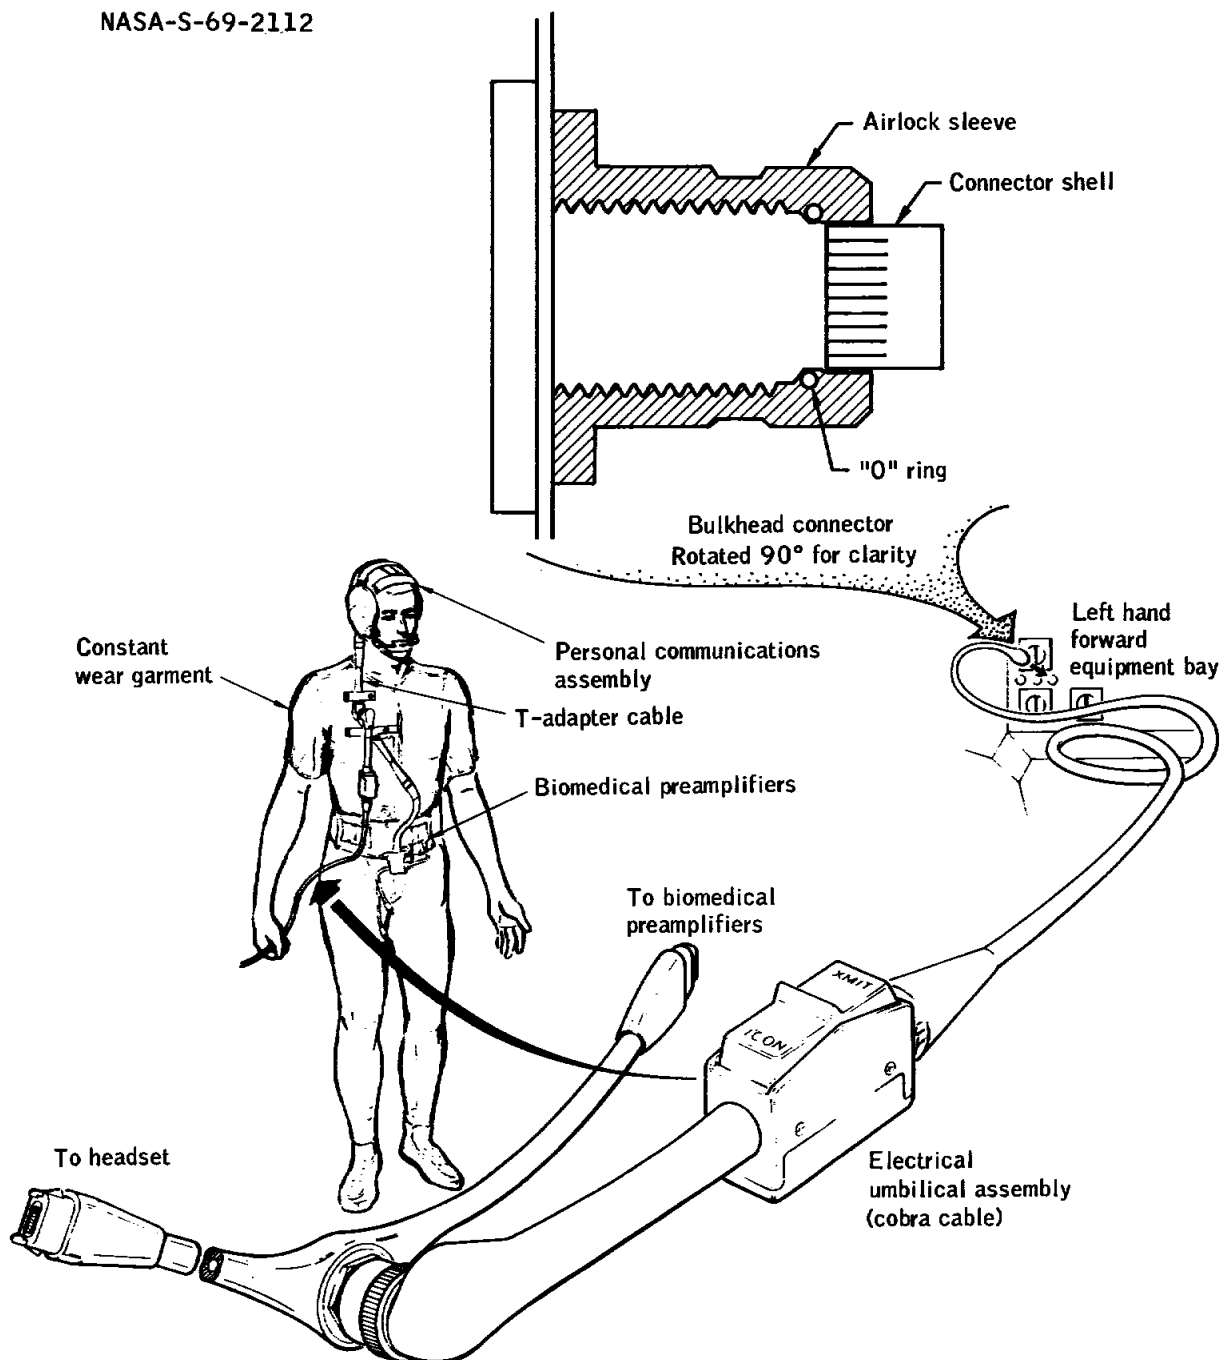
The commander reported one loss of communications while using the lightweight headset, and one loss while using the communications carrier. No hardware discrepancies were noted during postflight checks of the lightweight headsets and associated cables, control heads, and adapters (see fig. 17-34). The communication carriers and the commander's suit harness were also tested with associated cables and control heads and operated properly.

The airlock sleeves on the T-adapters were loose (see fig. 17-34) during mating and demating of the connectors for the postflight tests. Subsequent checks of the spacecraft showed a loose airlock sleeve on the bulkhead connector that mates with the commander's umbilical. Considering the worst case connector insert, pins, and airlock sleeve tolerances, an airlock sleeve loosened by one turn could cause loss of communications. During previous ground tests, loss of communications has been encountered because of improper mating of the lightweight headset connector to the suit harness and/or the T-adapter.

The most probable cause of the commander's loss of communication was either a loose airlock sleeve on one of three connectors, or an improper mating of the lightweight headset connector to the suit harness and T-adapter.

Figure 17-34.- Sectional view of airlock sleeve on connector shell.
